Manhole Inspection Summary

Manhole # S23KK_008MH

Location Address: **2411 WOODBROOK AVE** Cross Street: **WHITELOCK ST**

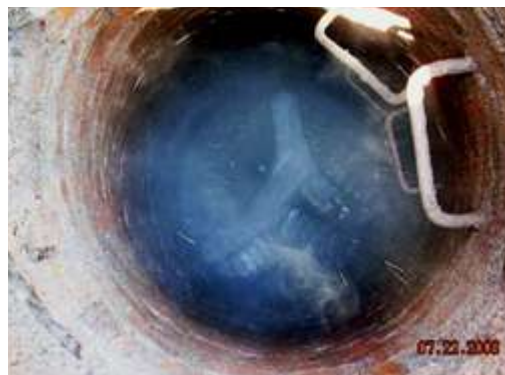
Top View

Corroded steps. Bench debris.

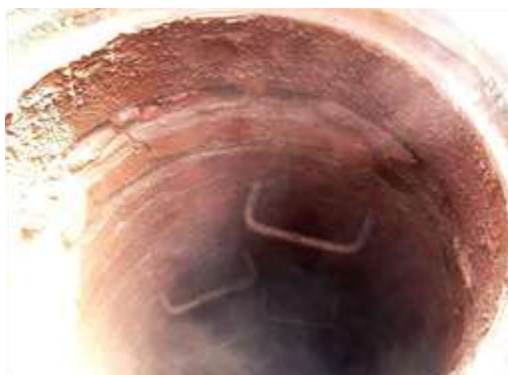
Defect

Frame leaks. Adjustment deterioration, loose brick and infiltration.

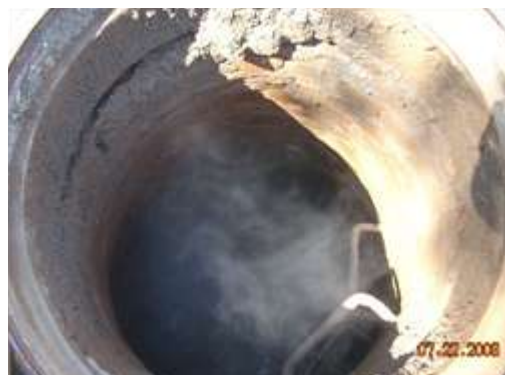
Defect

Frame leaks. Adjustment deterioration and infiltration. Barrel infiltration - other side.

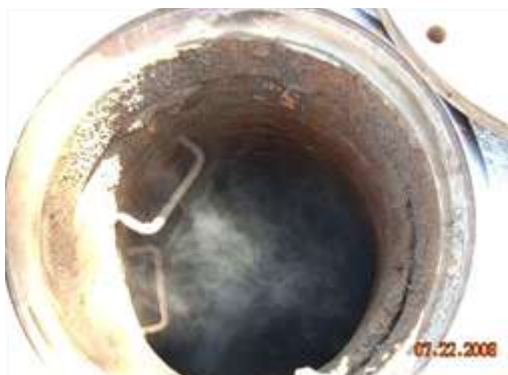
Defect

Frame leaks. Adjustment deterioration and infiltration. Barrel infiltration.

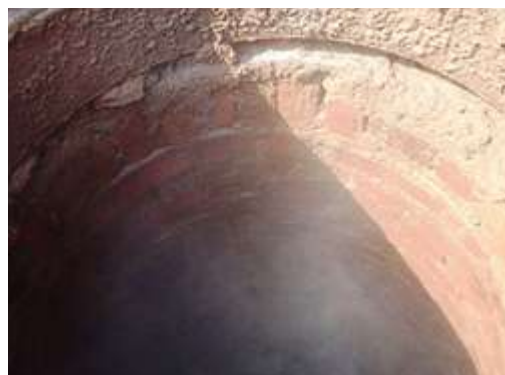
Defect

Frame leaks. Adjustment deterioration and infiltration.

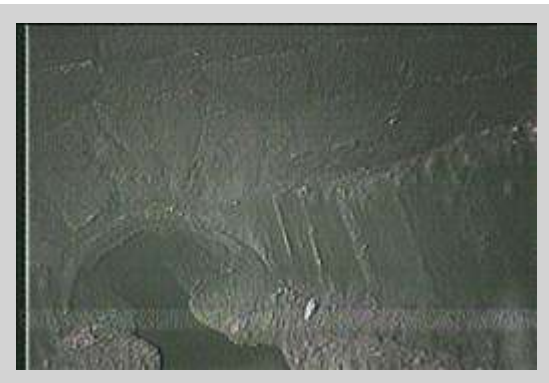
8 in. Circular Gravity Sewer Pipe In @ 4 O'Clock

Barrel deterioration and infiltration.

Deposits: ☐ None ☐ Mud ☐ Sludge ☐ Debris ☒ Grease

Silt Depth: **0** (in.) Deposits Extent: **Medium**

Infiltration: **Evidence** Pipe Seal Cond: **Cracked**
